LER-2003-002-00 [Automatic Reactor Scram (#107) Due To

A Partial Loss of Offsite Power]

**Grand Gulf Nuclear Station**

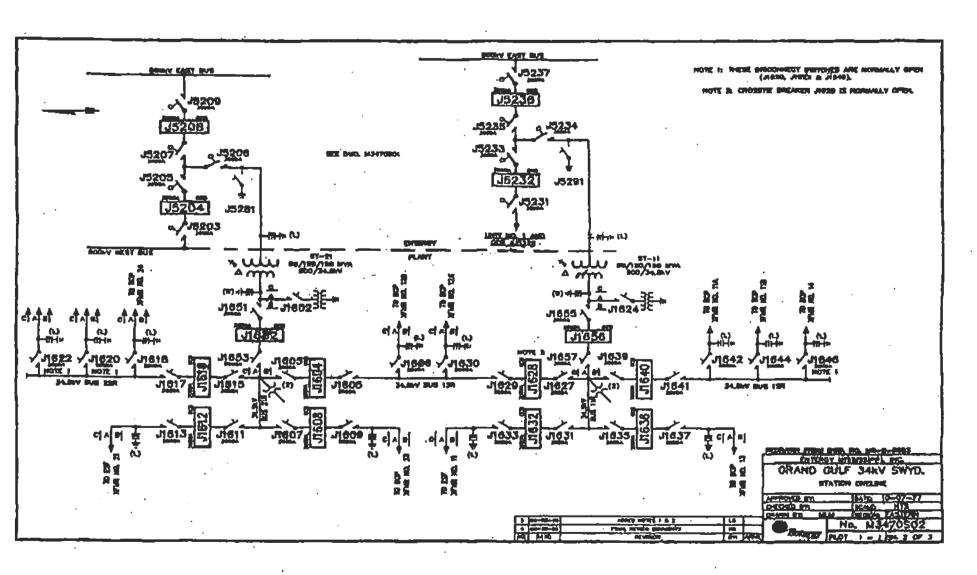
## Entergy Mississippi, Inc. Grand Guif 34kV Switchyard

- Schematic of the GGNS 34.5KV Switchyard.
- Schematic of the GGNS Distribution Switchyard.
